| Model | Model Code | Year Model | Issue Date |
| CR-V | RE5 | 07, 08 | 12-03-08 |
| CR-V I-CTDI | RE6 | 07, 08 | Originator<br>Product Technical/QIC<br>Product Technical/QIC |

## **Creaking Noise when Windshield Wipers are on - RHD Only**

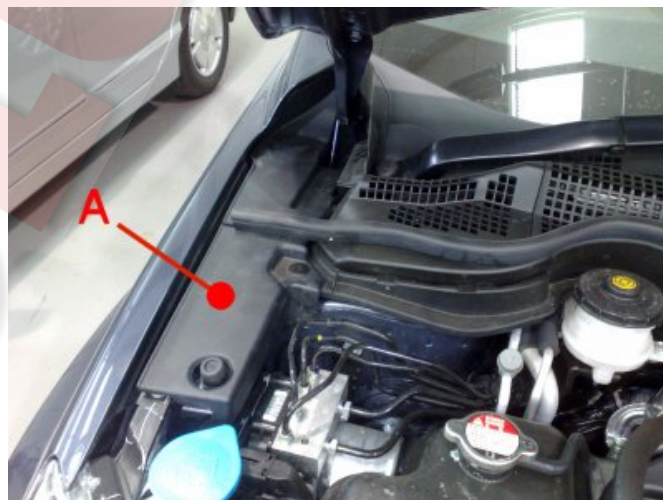
A - Remove this panel.

1. Open the bonnet and remove the Rubber, R. Hood Seal. Prop the bonnet open in the most upright position.

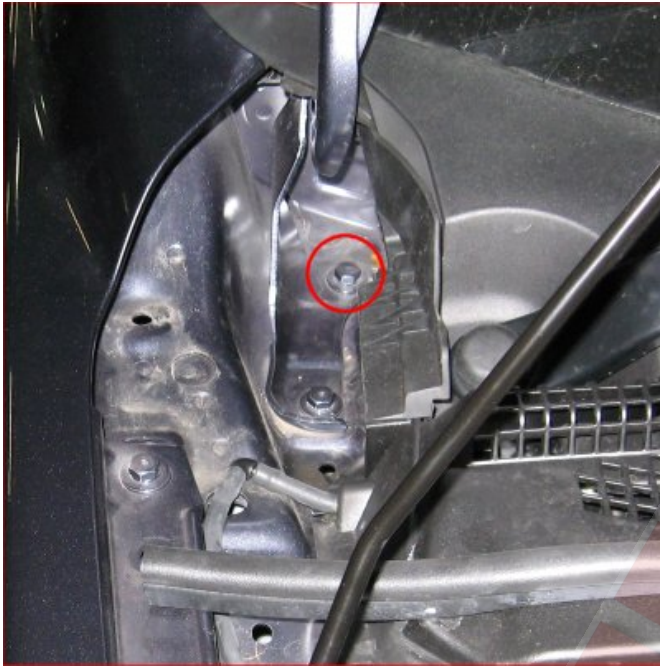
3. Use the inspection mirror to check for contact

between the two panels.

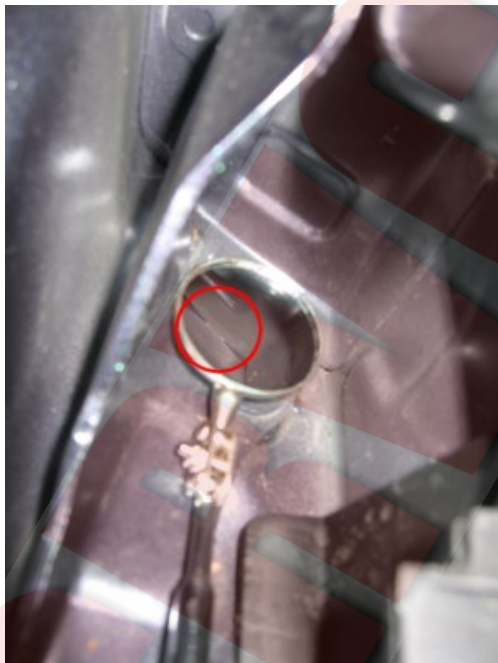
Position the mirror above the rear mounting bolt of the bonnet stay with the mirror facing upwards.

With the mirror correctly positioned you can see the contact point between the two panels.

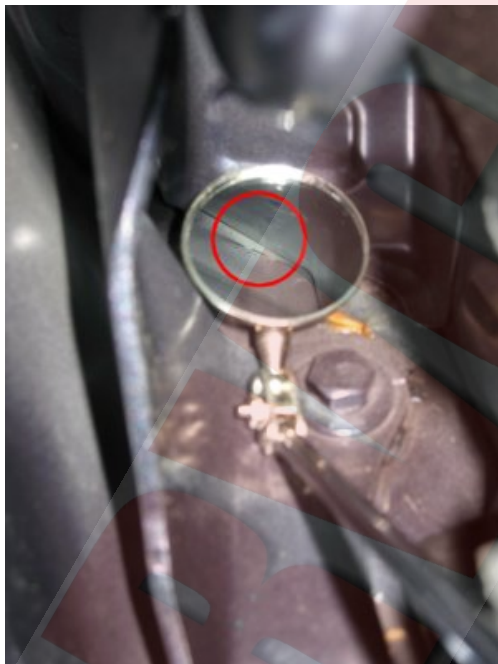
7. Check whether the contact point has been opened, only a small gap is required to stop the noise.

8. Operate the wipers to confirm that the noise no longer occurs.
9. Cover the contact and impact areas with the wax to cover any surface damage which may have occurred.
